DOE/EV-0032

Report on the Explosion, Fire, and Oil Spill Resulting in One Fatality and Injury on September 21, 1978, at Well 6 of Cavern 6 at the West Hackberry, Louisiana, Oil Storage Site of the Strategic Petroleum Reserve

November 1978

U.S. Department of Energy
Washington, D.C. 20545

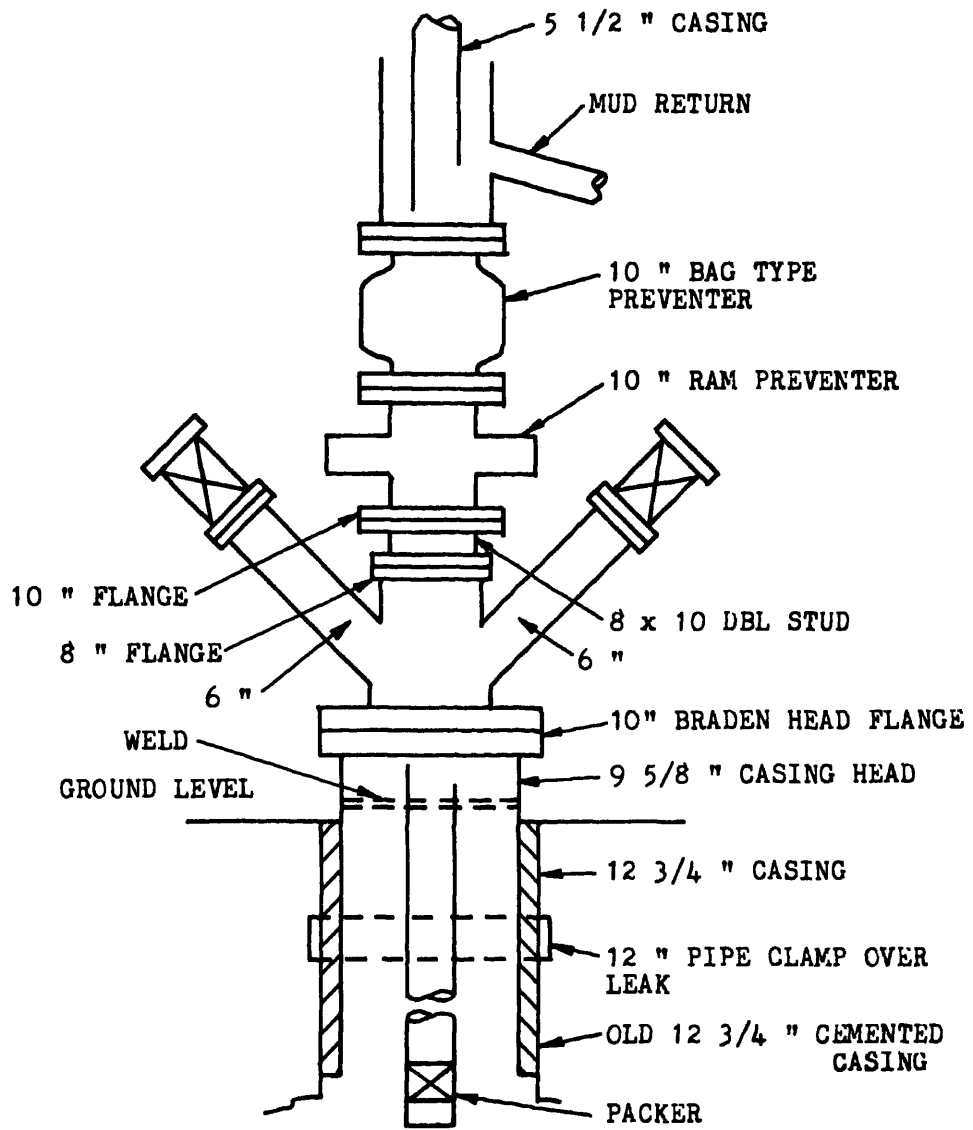
Figure 6b. Well 6 Configuration at Time of Blowout

Figure 6b shows Well 6 at the time of the blowout with a bag-type blowout preventer, a ram preventer, the mud return line, and packer.

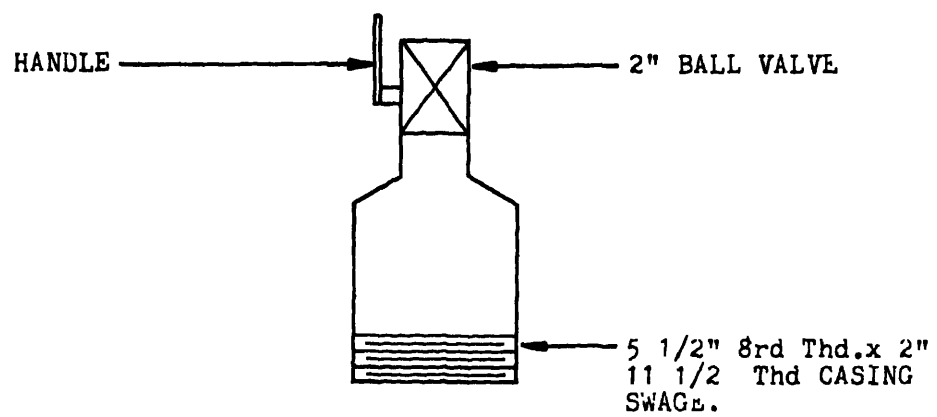
Figure 8. Safety Valve for Use as Stabbing Valve as Made up for Well 6

Figure 8 shows the safety valve used on the rig at the time of the accident. The device consists of a 5-1/2-inch by 2-inch casing swage with a 2-inch ball valve. To be utilized as a safety valve, it must be screwed into the top of the 5-1/2-inch casing to control the flow of fluids.

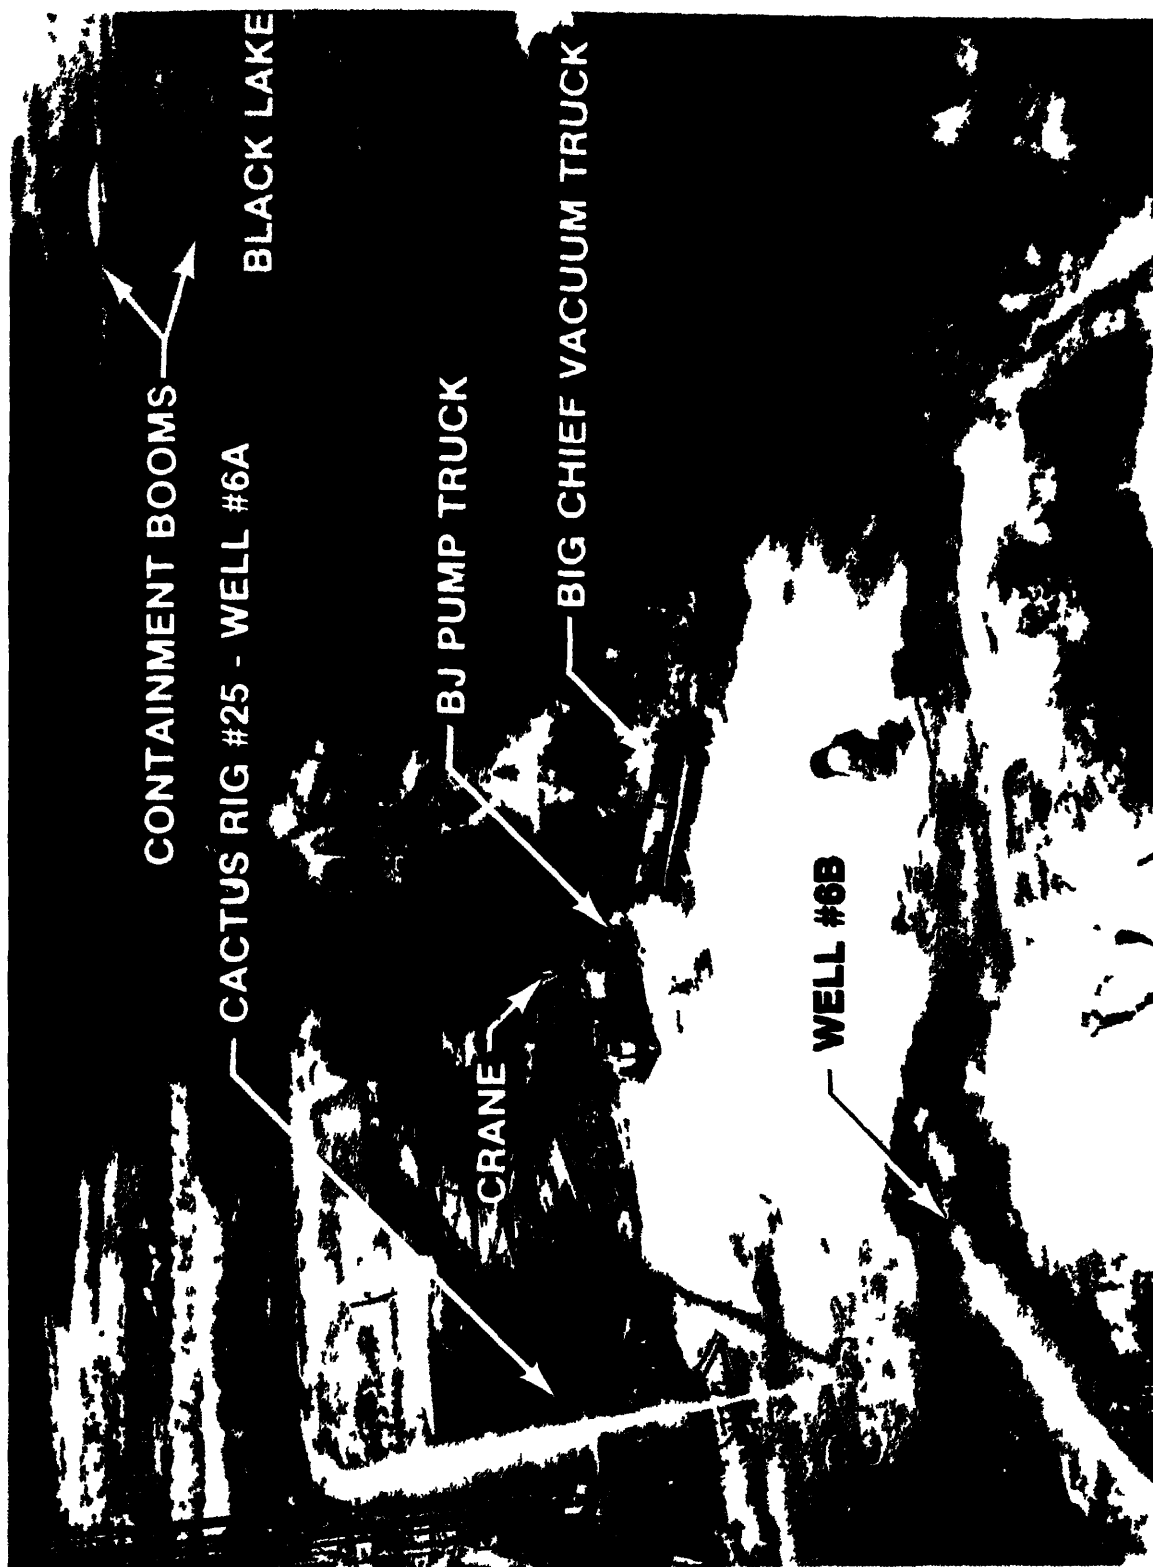
FIGURE 12. SITE DURING FIRE.

Figures 12, 12a, and 13 are photographs of the fire scene; 12a on September 21, and 12 and 13 on September 22, 1978. Figure 12 is a view of the site taken by helicopter. It shows the Cactus Rig on Well 6A prior to its being pulled back off the well head with a water stream being sprayed on the rig in an attempt to keep it cool in order to minimize fire damage. Several items which were destroyed by the fire are also evident in the picture. In the top right corner are the oil booms deployed to help contain the oil spill on Black Lake. Figure 13 is a closeup photograph of the fire and was taken from the Cavern 6 pad.

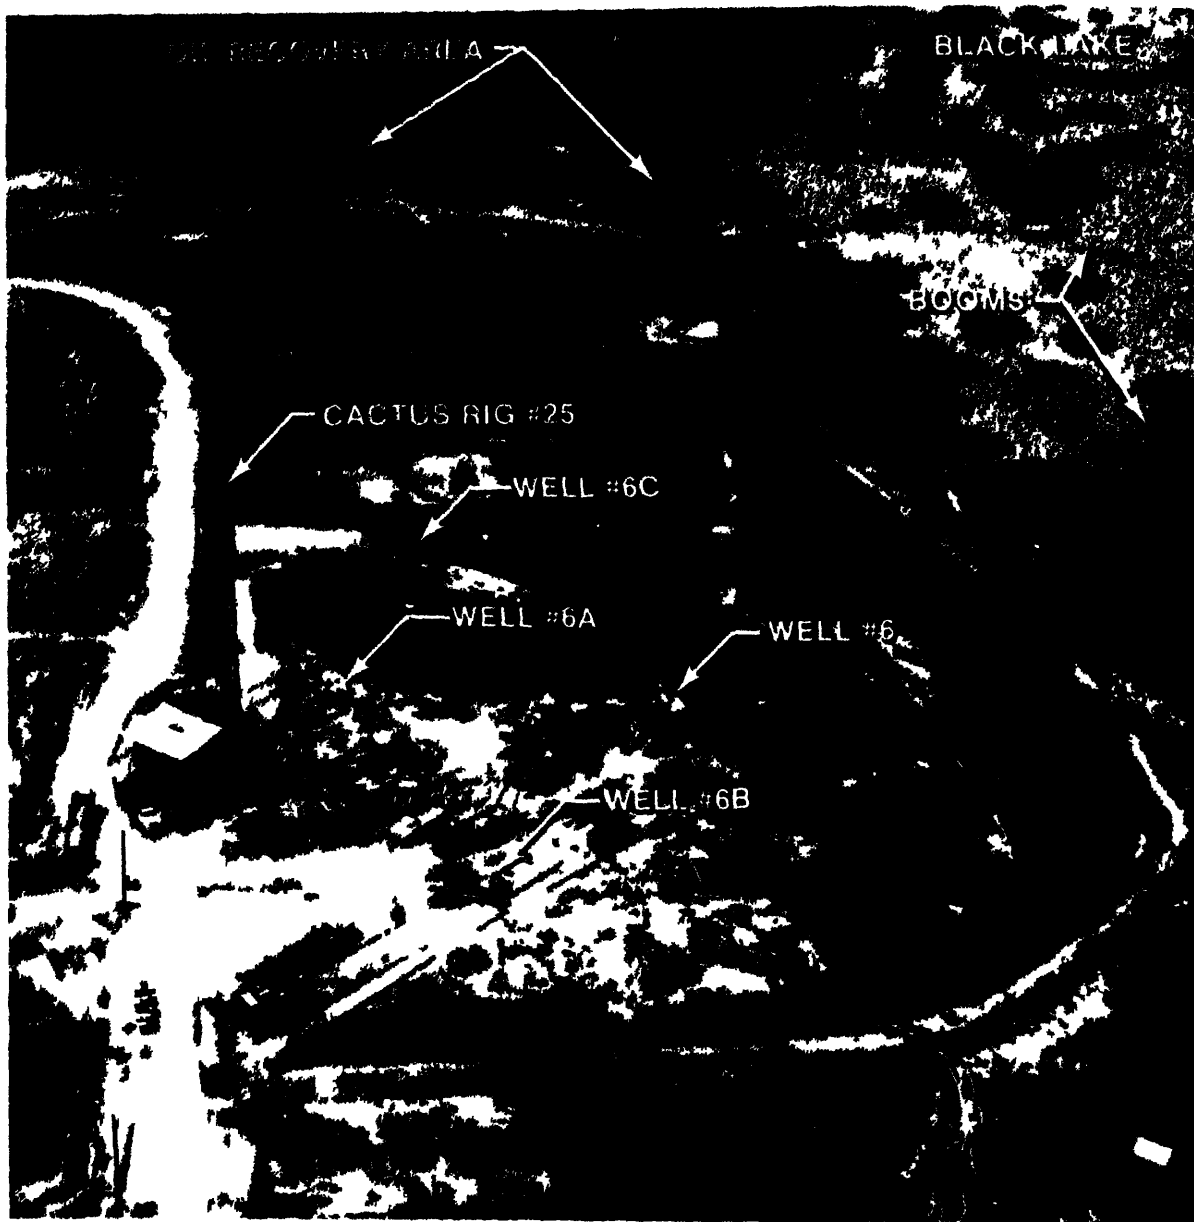
FIGURE 14. SITE AFTER FIRE.

Figure 14 is a representative helicopter photograph of Pad 6 after the fire had been extinguished. It was taken on September 27, 1978. The new well head had not yet been placed on Well 6. It shows that the oil spill cleanup operations had recovered almost all the oil which had spilled onto Black Lake.

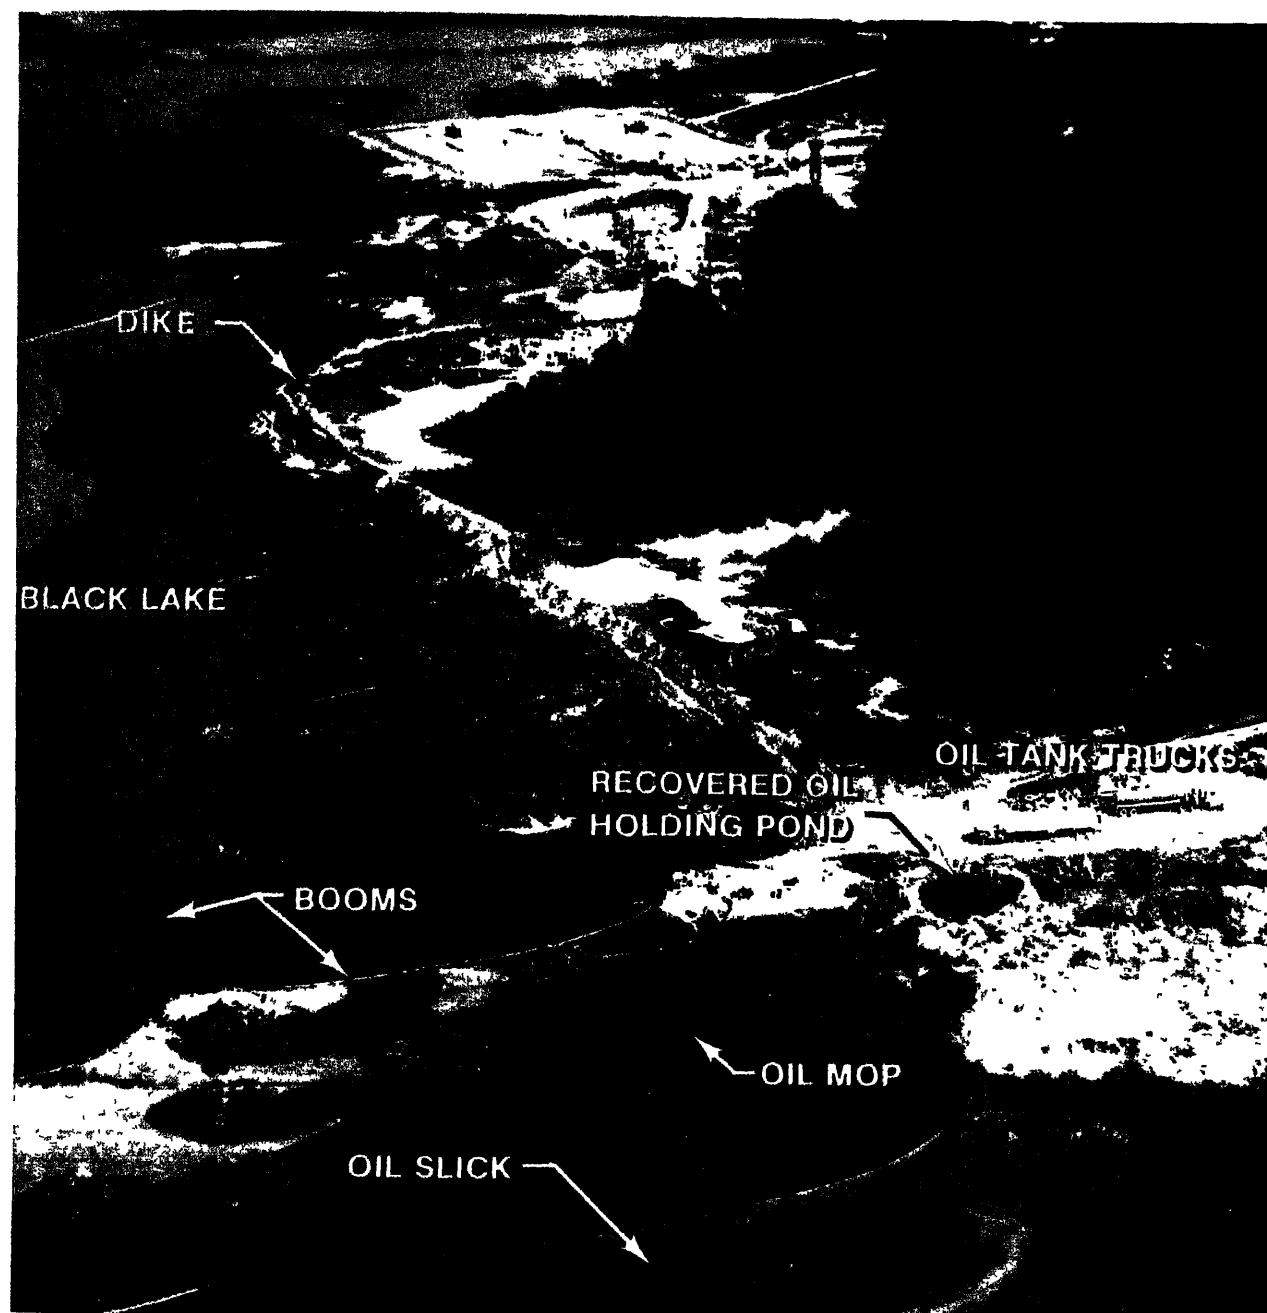
FIGURE 25. DIKE SYSTEM.

There was a dike in place around Cavern 6 as shown in Figure 25, but the dike was inadequate to contain the spill from Well 6; additionally, there was a defect in the dike which had not been repaired. When the spill into Black Lake occurred, the initial boom was obtained from Amoco's adjacent facility and was installed by Parsons-Gilbane personnel with subsequent assistance from the U.S. Coast Guard when they arrived on the scene. Additional backup

booms were obtained from and installed with the assistance of local cleanup contractors. Figure 25 also shows some of the oil tank trucks which were used to remove the oil collected from the site.

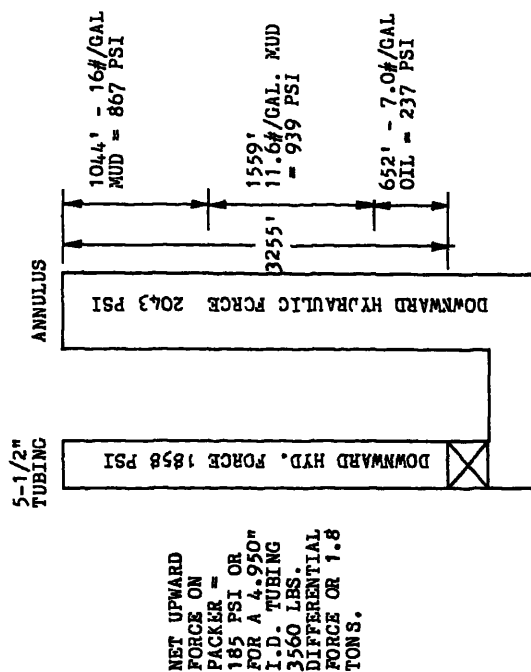
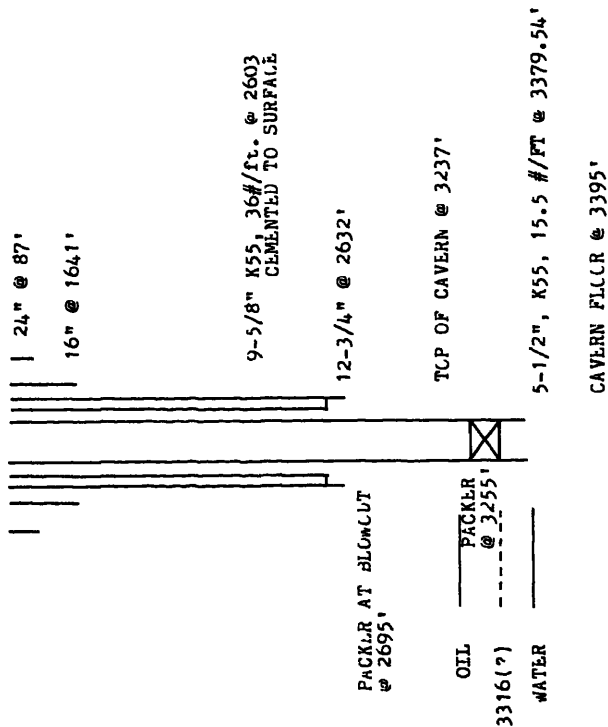
Figure 28. Initial Hydraulic Forces on the Packer

The analysis of the well bore conditions when the packer was set, before the tubing was pulled out of the hole, is shown in Figure 28. The U-tube representation of the hole shows that

THE CONDITIONS IN WELL 6 CAN BE REPRESENTED AS A "U" TUBE FOR THE PURPOSE OF ILLUSTRATING THE HYDRAULIC PRESSURES ON THE TAM PACKER.

there was a 185-psi differential across the packer or a total differential force of 3,560 pounds. When 14 joints of tubing had been pulled out of the hole and the packer had been moved up the hole with the bottom of the pipe to 2,820 feet, the hydraulic forces were as shown in Figure 29. The U-tube representation of the forces within the hold at that point indicate that there was a 367-psi differential or a 7,063-pound total differential force being exerted upward on the packer.

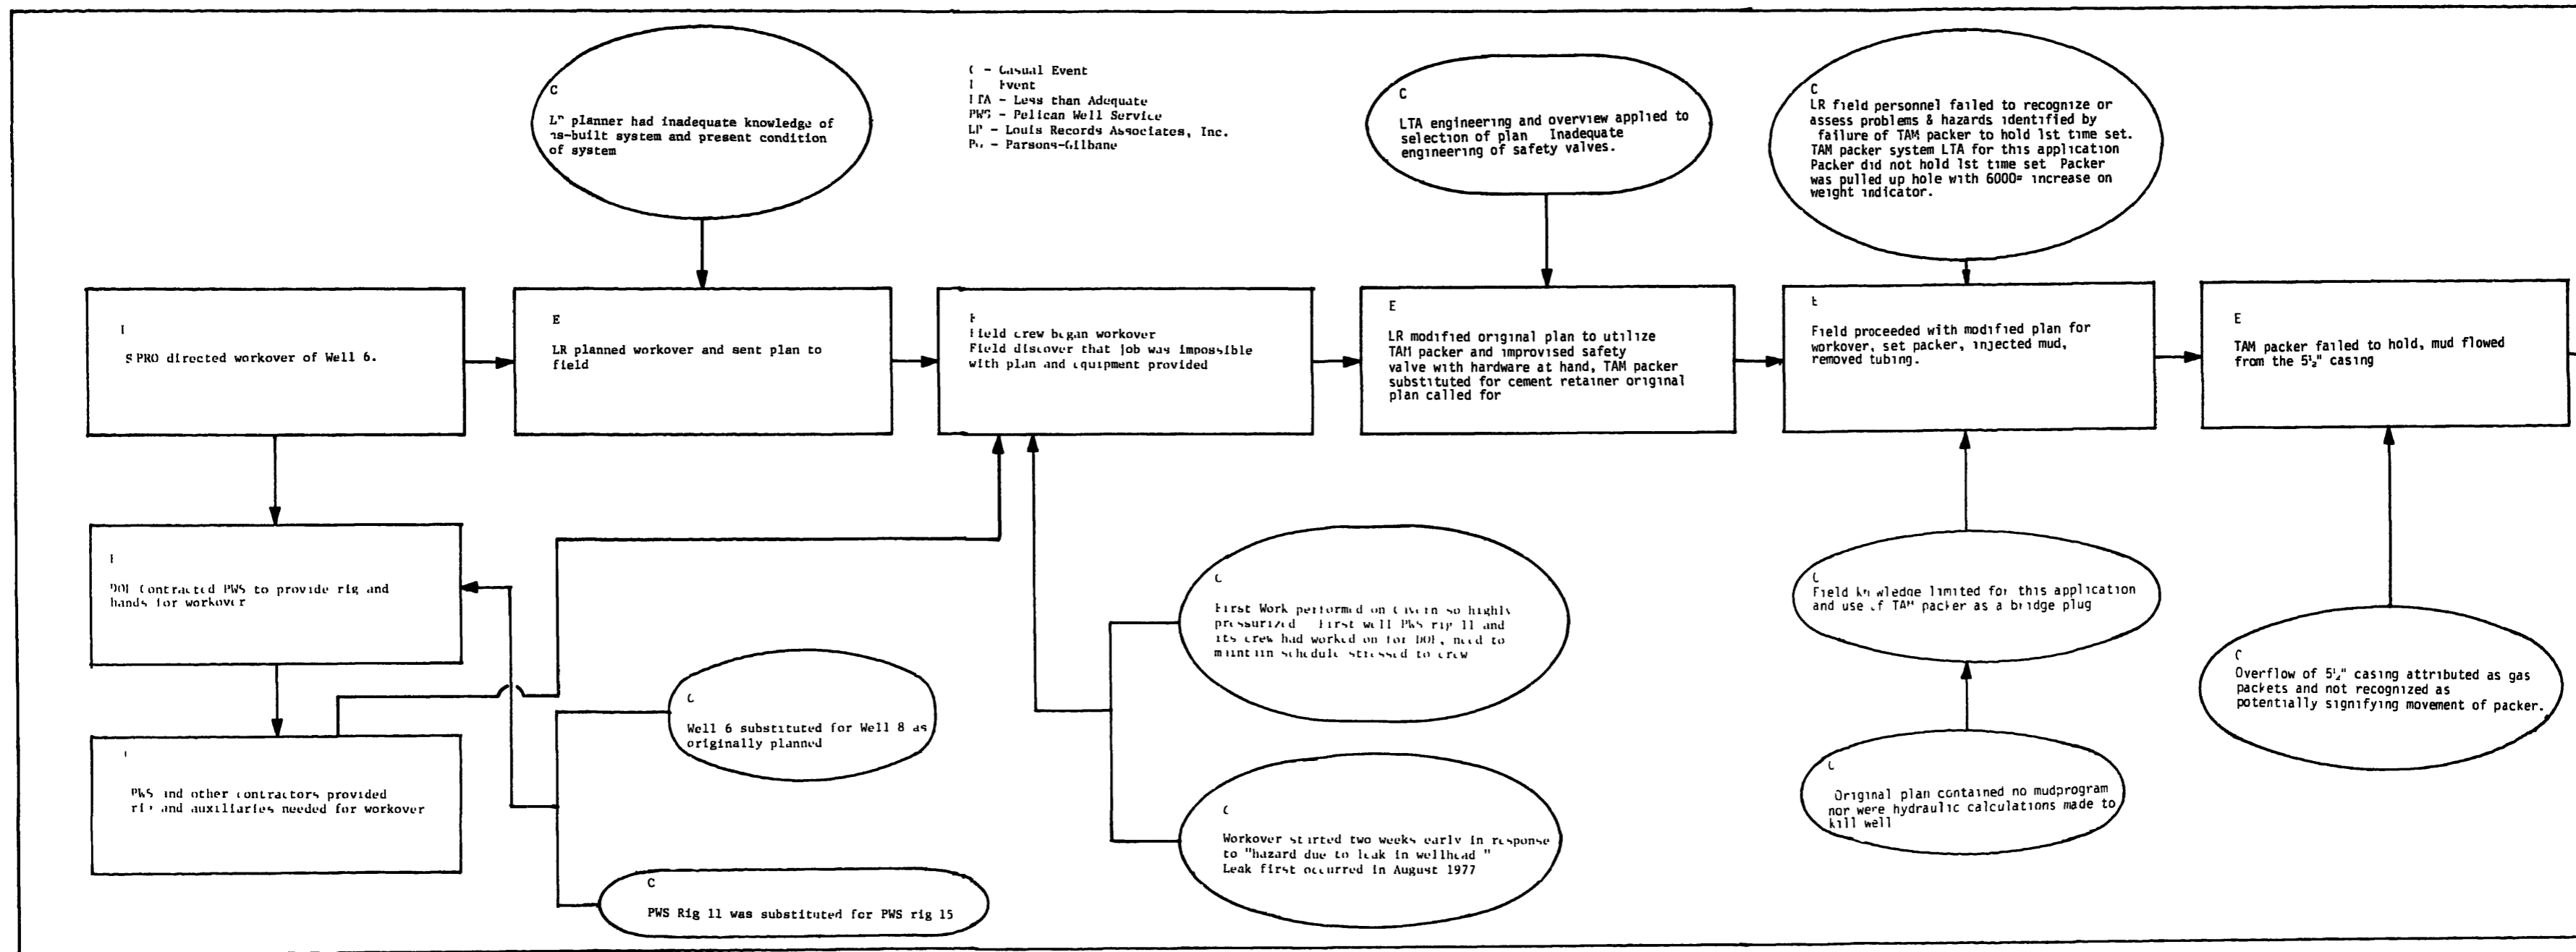
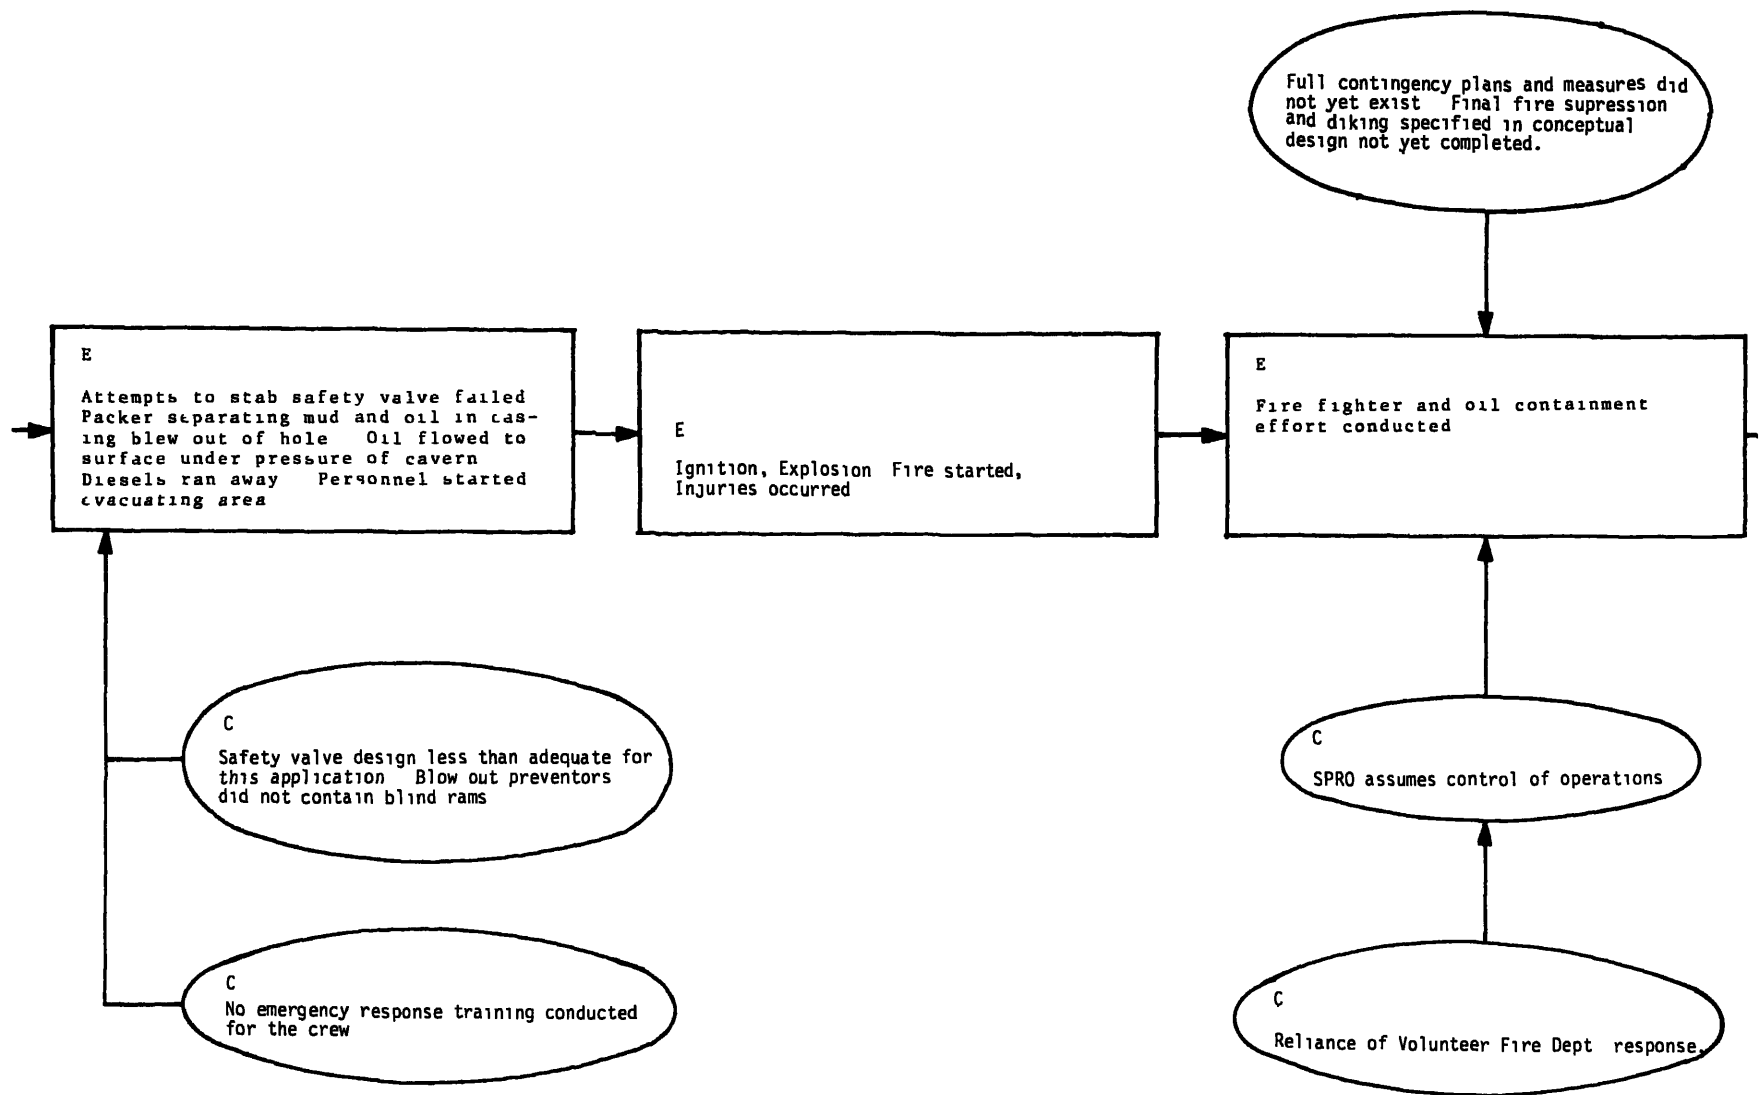
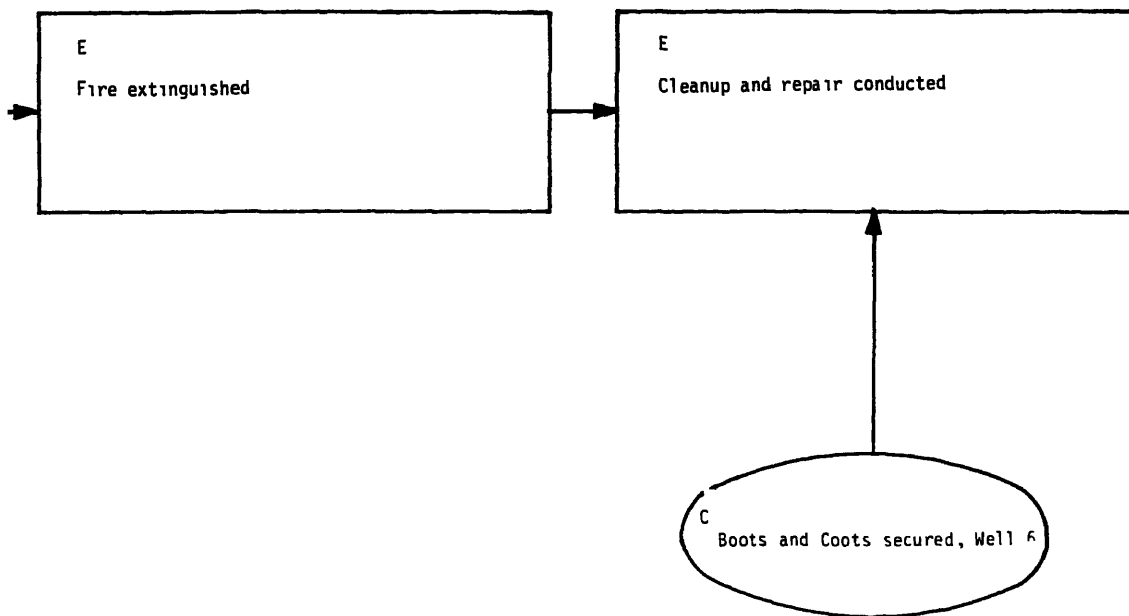
Figure 30. Analysis of Workover Operations (Events Sequence Chart)

There are a number of key management activities and decisions that contributed to developing the events surrounding the accident. This section of the report is divided into two major subsections: (1) a description of 11 key events; and (2) the management actions relative to those events. Figure 30 shows the relationships between these events. Attachment I gives a much more detailed representation. The analysis in this section goes up to the beginning of the fire ($T = 0$). The next section of the report carries the discussion on through the emergency response period ($T = 0$).

- (3) The Pelican Well Service field crew began to execute the workover procedures and discovered they could not perform the job according to the procedures because of the well hardware conditions encountered and the equipment available.

- (4) Louis Records' main office and field management participated in developing a modified plan using a TAM packer. No other safety backup was utilized except for a manually controlled safety valve improvised at the site.

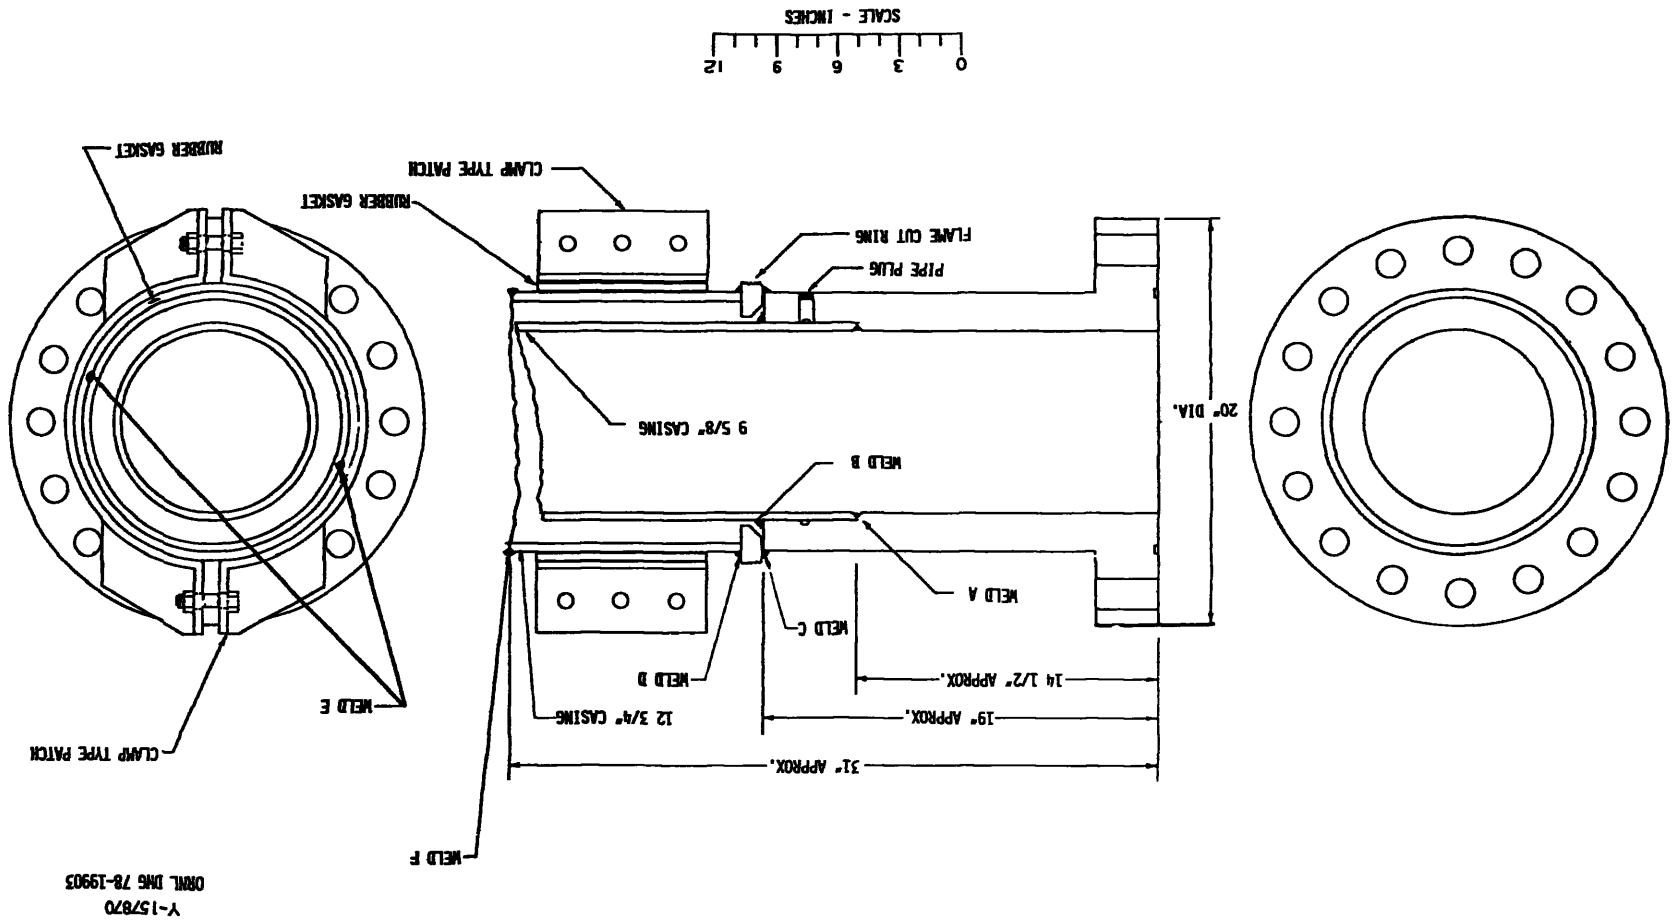
B, C and D can be seen in the photographs shown in Fig. 9. Likewise, a through-leak was found in a longitudinal weld in the outer casing (Figs. 10 and 11) which were located under the clamp-type patch. This longitudinal weld is identified as Weld E (Fig. 3). Thus, a potential leak path for petroleum was found leading from the inside of the 0.24-m-diam (9 5/8-in.) pipe through the internal bore weld (Weld A, Fig. 3) into the annulus between the inner and outer casing, through the weld (Weld B, Fig. 3) at the end of the annulus and to the outside through the longitudinal weld of the outer casing.

Fig. 3. Drawing of Wellhead Assembly Received at Oak Ridge National Laboratory.

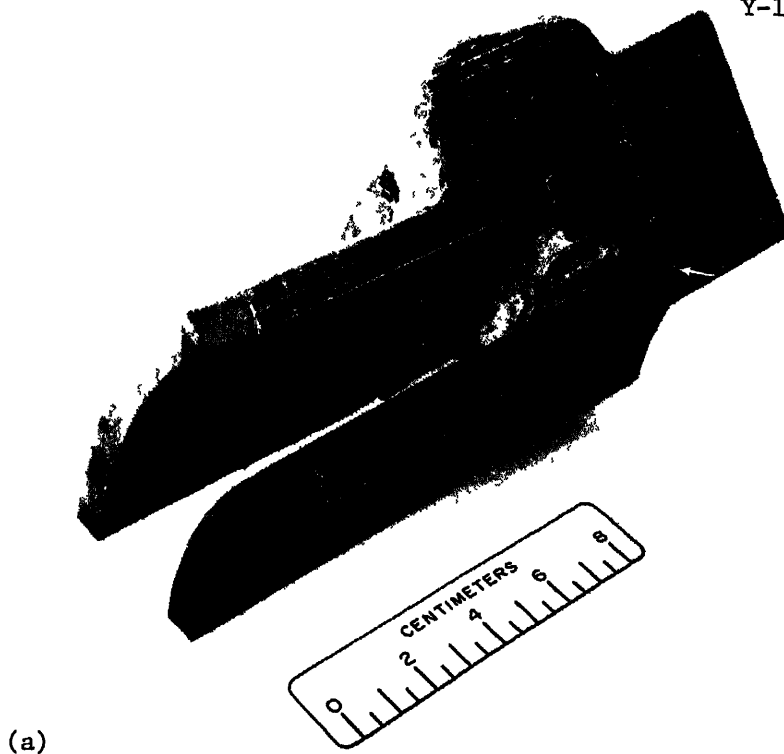
Y-157706

A flame-cut spacer which had been welded between the heavy walled wellhead and the thinner walled outer casing is shown in Fig. 8. Photographs showing end and side views of one of the dissected segments revealed this ring spacer. The welds making this attachment of the spacer are identified as Welds C and D (Fig. 3). Dye-penetrant inspection of the inner weld (Weld B, Fig. 3) which attaches the 0.24-m-diam (9 5/8-in.) pipe to the heavy pipe section of the wellhead revealed severe cracking and a through-leak. A longitudinal view of the area containing Welds

Fig. 8. Two Views of Section of Wellhead Assembly Containing Flame Cut Spacer Ring (Arrows) Which had been Welded Between the Heavy Walled Wellhead and Outer Casing (see Fig. 3, Welds C and D).

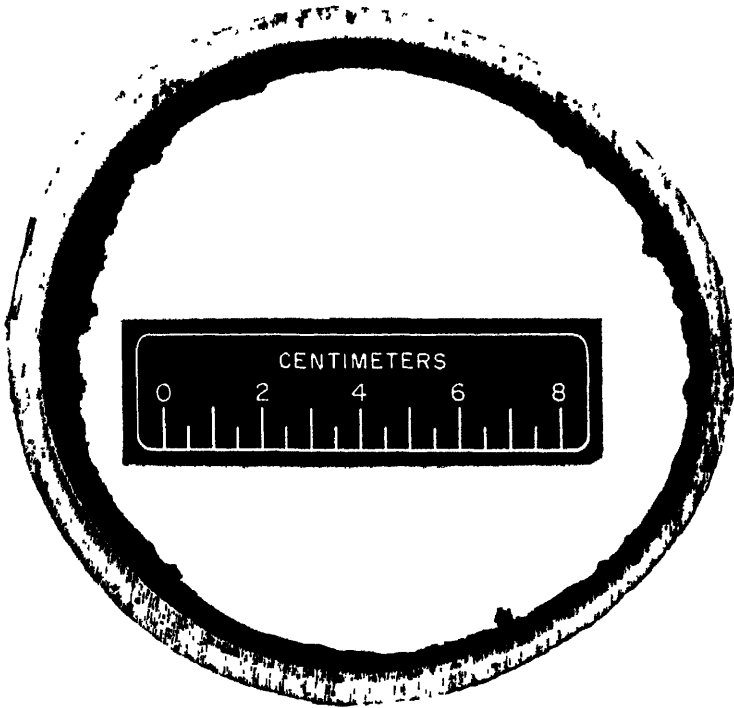
A typical pipe of this type designated as Pipe 2, was dissected to permit further examination and is shown in Fig. 18. The extensive amount of loosely adherent internal scale (powder) is evident in Fig. 19. Considerable variation in the wall thickness can be seen in Fig. 20. Typical microstructures of Pipe 2 is shown in Fig. 21. The black loosely-adherent powder reaction product found in Pipe 2 was extremely light weight and contained sufficient magnetic material in it to be attracted by a magnet. Although x-ray diffraction showed the metallic oxide to be primarily Fe_2O_3 , undoubtedly some magnetic Fe_3O_4 and/or metallic Fe was present. Approximate chemical analysis of the powder showed 40% Fe, 17% C, and 600 ppm Cl.

Fig. 20. Section of Pipe 2 Showing Wall Thinning.

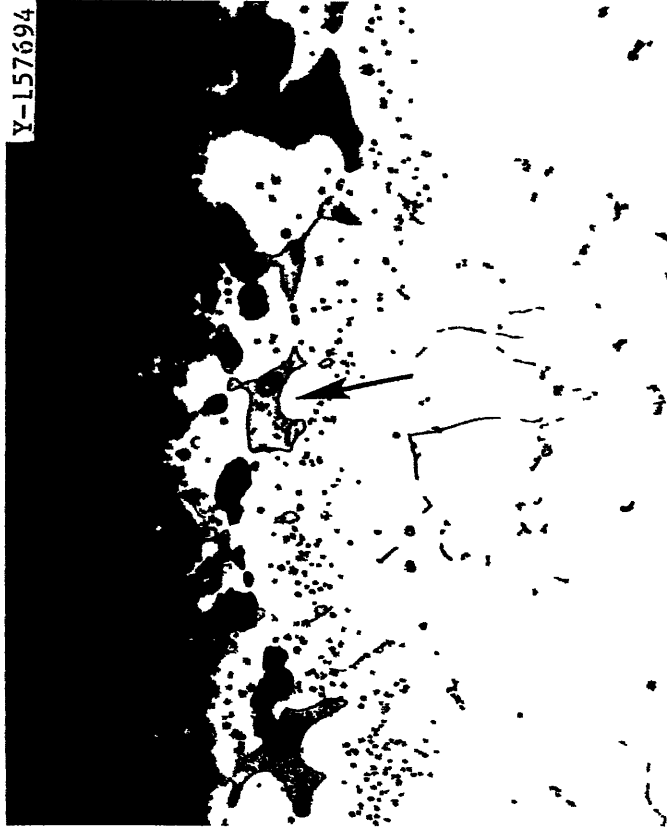
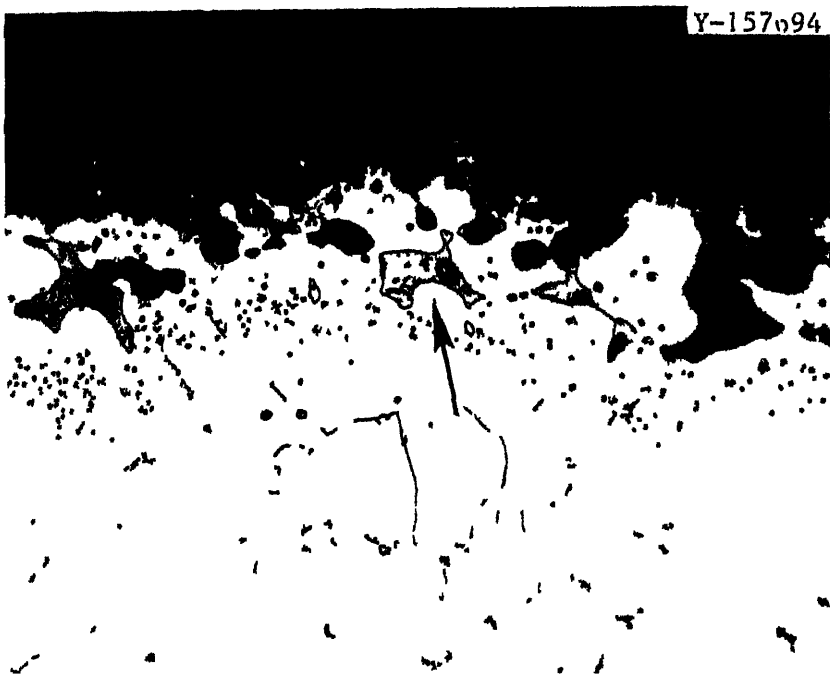
Fig. 26. Pipe 3, Eutectic Structure (arrow) in the Base Metal Near the Deposit. 500x

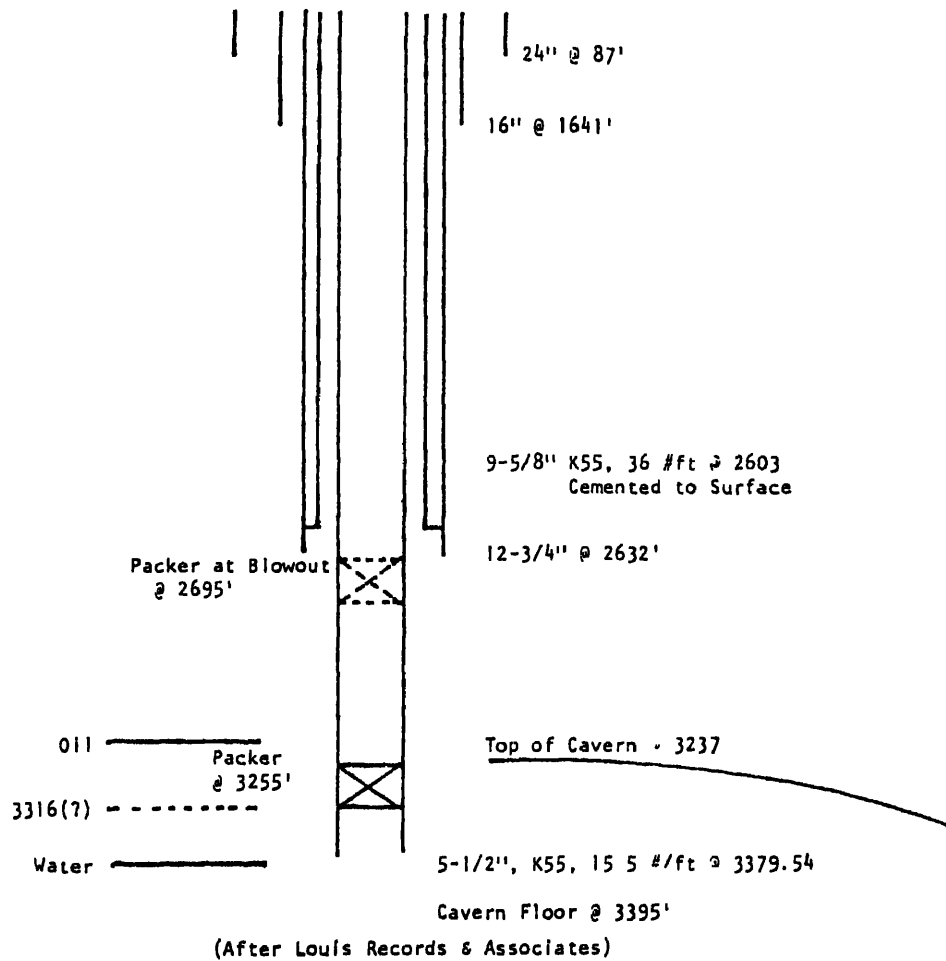
Figure 2. Casing Configuration on Well 6.

The configuration of the casing is shown in Figure 2. The drawing was taken from a sketch drawing labeled "Gulf Interstate Engineering Company" and dated 2/9/78. The casing weight and grades were taken from other Gulf Interstate Engineering Company records. The depths and sizes from Figure 2 will be used in this report.

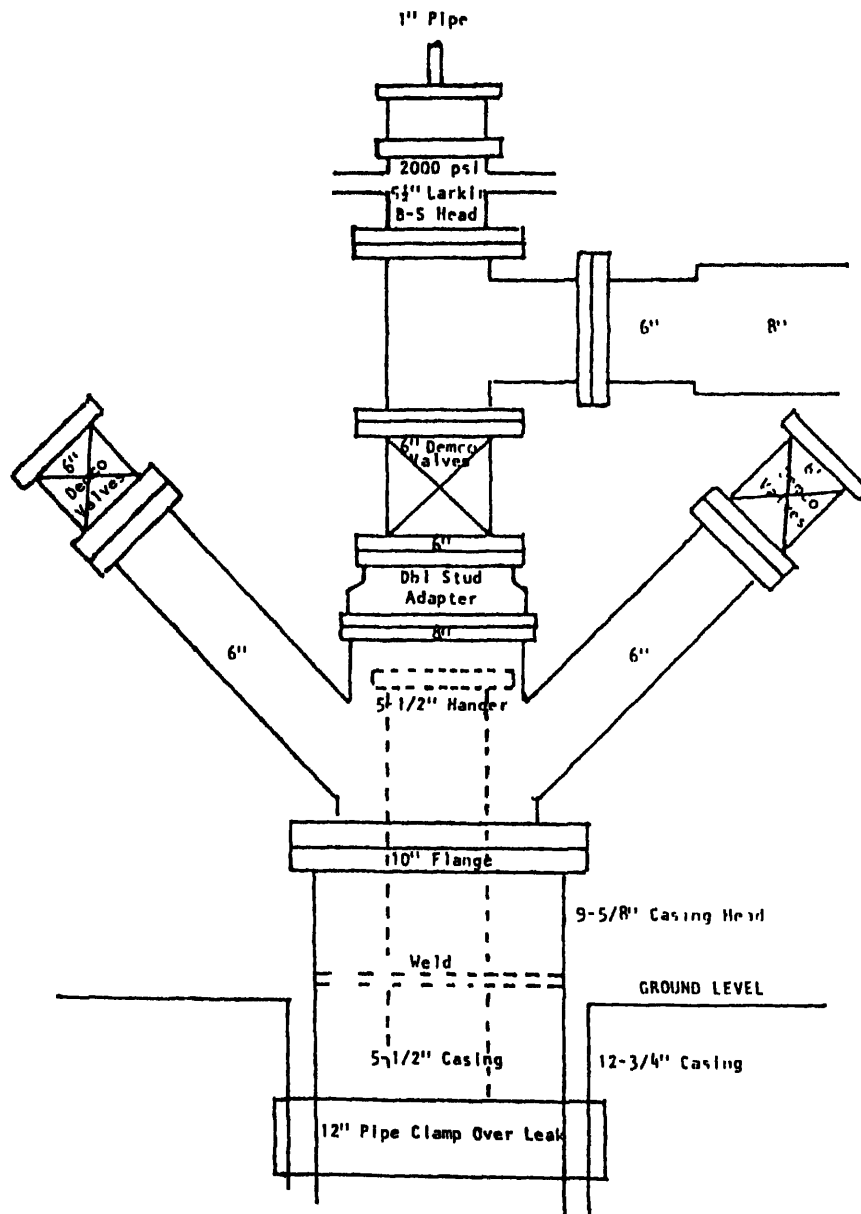
Figure 3. WEST HACKBERRY - CAVERN WELL NO. 6
BEFORE WORKOVER STARTED
(after Louis Records & Assoc.)

The configuration of the wellhead before the workover started is shown in Figure 3. The original sketch is with documents provided by Gulf Interstate Engineering Company and Louis Records and Associates. Figure 4 is a photograph of Well #11 that is supposed to be similar in all respects to the wellhead that was on Well #6. The photograph was taken September 29, 1978, at my direction by photographers assigned to the investigative committee.

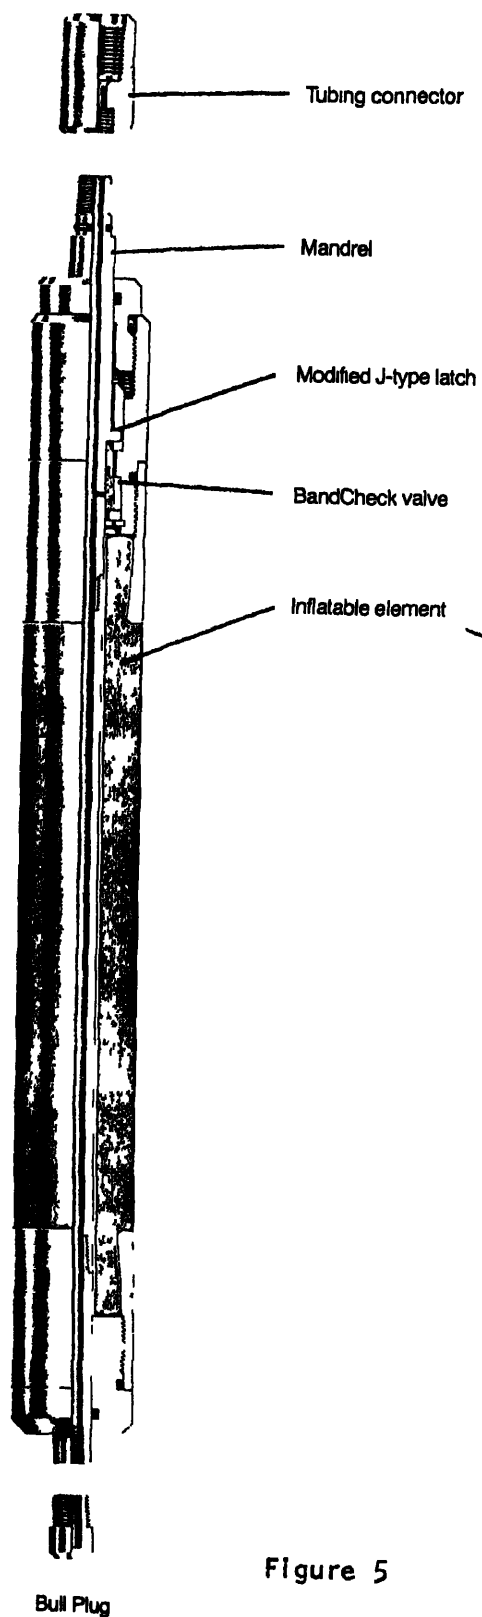
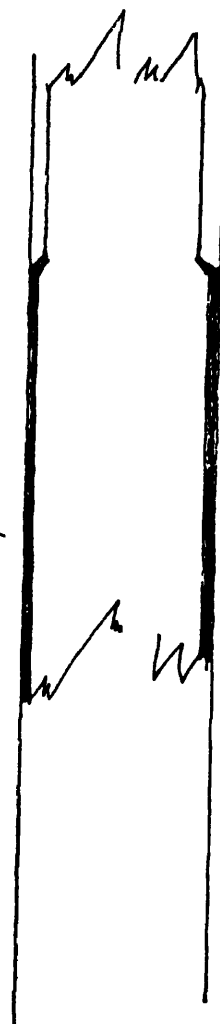
Figure 5-A

The TAM packer is shown in Figure 5 and as it was in the hole in Figure 5-A.

The TAM inflatable packer is held in the hole by the frictional force of the rubber set against the tubing or hole. The TAM International Working Pressure Chart as shown in Figure 6 indicates that the 4-1/4" packer used should have withstood a differential pressure of approximately 5000 psi. It appears the

It is unlikely that the packer deflated since to deflate the packer, it must be rotated one-quarter turn to the left and then the mandril picked up. Investigation of the burned packer at the TAM plant in Houston did not indicate that the packer pressure was released.

4-1/4" Packer Inflated
in the 5-1/2" Tubing
(5-1/2" Tubing has 5" I.D.)

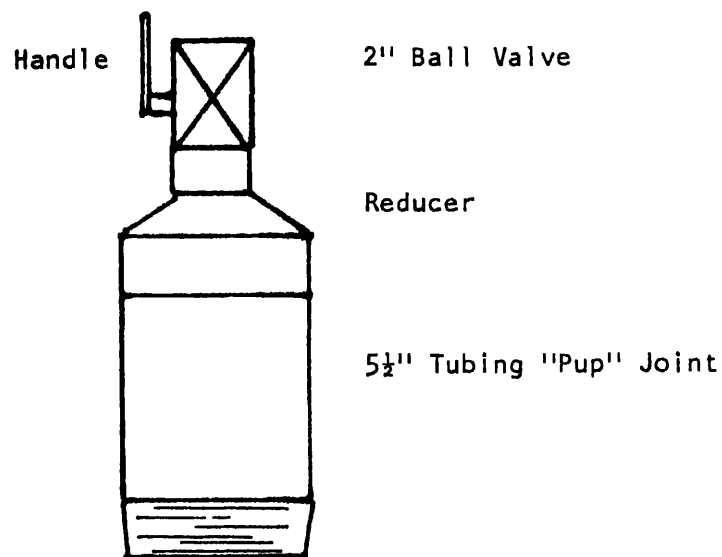
Figure 7. Safety Valve for use as stabbing valve as made up for Well 6.

The safety valve used as a stabbing valve on the Pelican rig was assembled by the drilling foreman, Mr. Irby Hogue, from a short "pup" joint of 5-1/2" tubing and a 2" ball valve from the wellhead (Figure 7). The BJ cementer testified he brought up a 5-1/2" x 2" cementing head when the well started to flow. The cementing head would be essentially similar to the drawing in Figure 7.

As a stabbing safety valve, the valve as made up has two difficiencies:

1. The valve has no handles to facilitate its being quickly installed on the tubing.
2. The valve should be full opening. A restriction in the valve will build a back pressure when the valve is being stabbed that will make it difficult to install on the flowing tubing.

Items 1 and 2 were what happened according to Mr. Hogue's testimony. He and the crew could not get the valve down on tubing threads. This was because of the restriction in the valve and the lack of handles. However, it needs to be noted here that a 5-1/2" safety valve is not a standard (off the shelf) piece of equipment.
